# BOULBY MINE, NORTH YORKSHIRE

At the height of the pandemic, construction was one of the few sectors that continued working. One such project being worked on was the repairs to a mine-shaft building in North Yorkshire. In this article, **Matt Robinson** of **Concrete Repairs Limited** reveals how the works were carried out, and what made the project a success, and reports on the carbon emission savings achieved for the client.

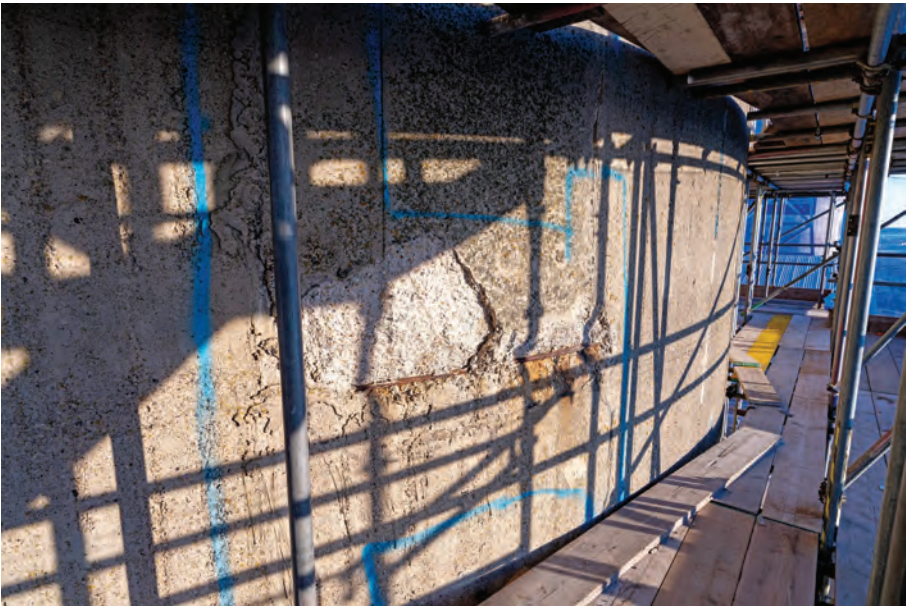
**BELOW LEFT:**  
Figure 2 – shaft with  
scaffolding in place.

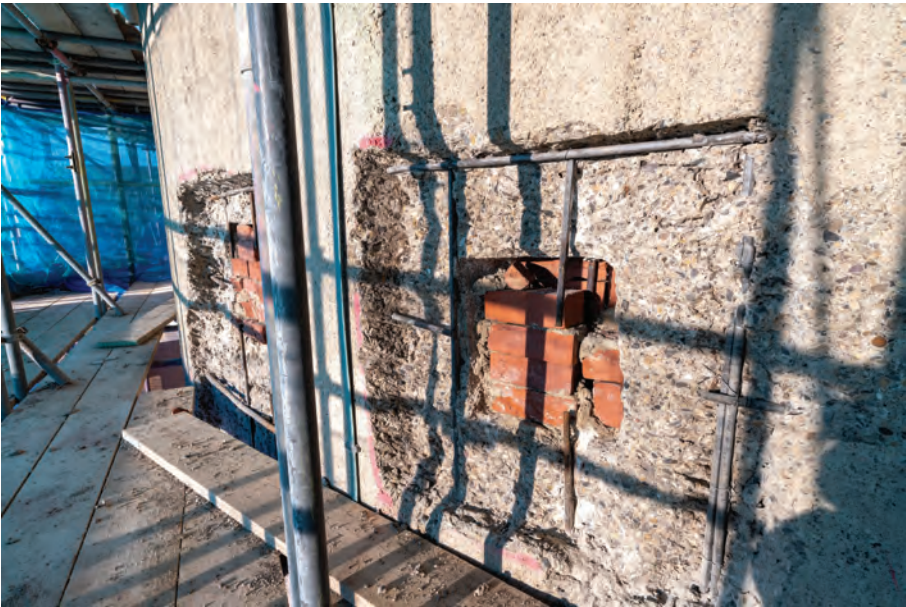
Extensive survey works identified that significant areas of repair were required to both the external and internal faces of the 300mm-thick concrete wall. There were large areas of cracking and spalling to a depth of between 80 and 100mm, as a result of corrosion of the reinforcing bars. The effect of this was large volumes of concrete were

**RIGHT:**  
Figure 3 – area of spalling  
prior to breaking out.

Externally, the works involved the design and erection of a 45m-high, fully encapsulated scaffold/access system around the perimeter of the shaft. Hydro-demolition was used to remove 31m<sup>3</sup> of defective concrete. Replacement reinforcement steelwork was fabricated to match the curvature of the structure prior to installation, while the remaining steelwork was cleaned and fully prepared by removing all rust and laitance.

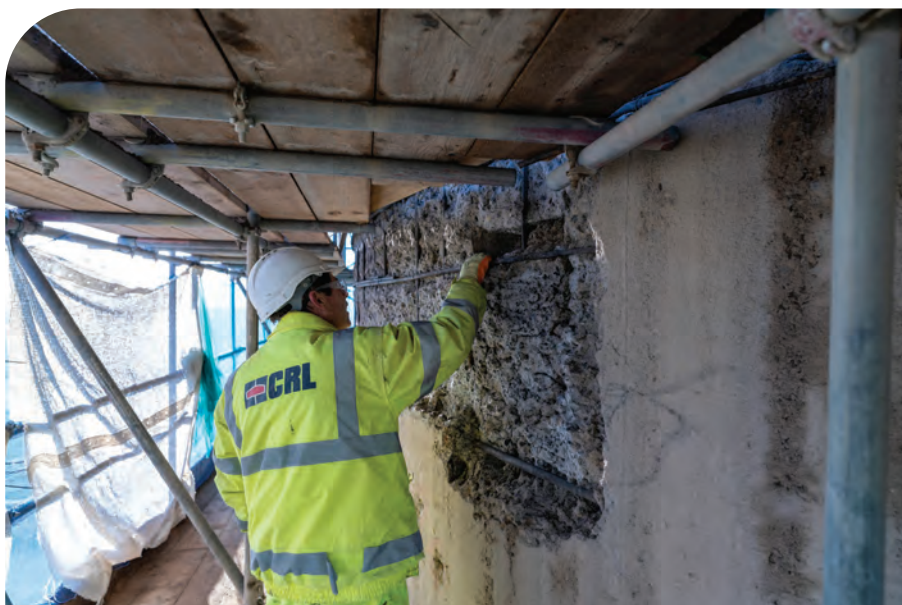
**BELOW RIGHT:**  
Figure 4 – typical area  
requiring repair.

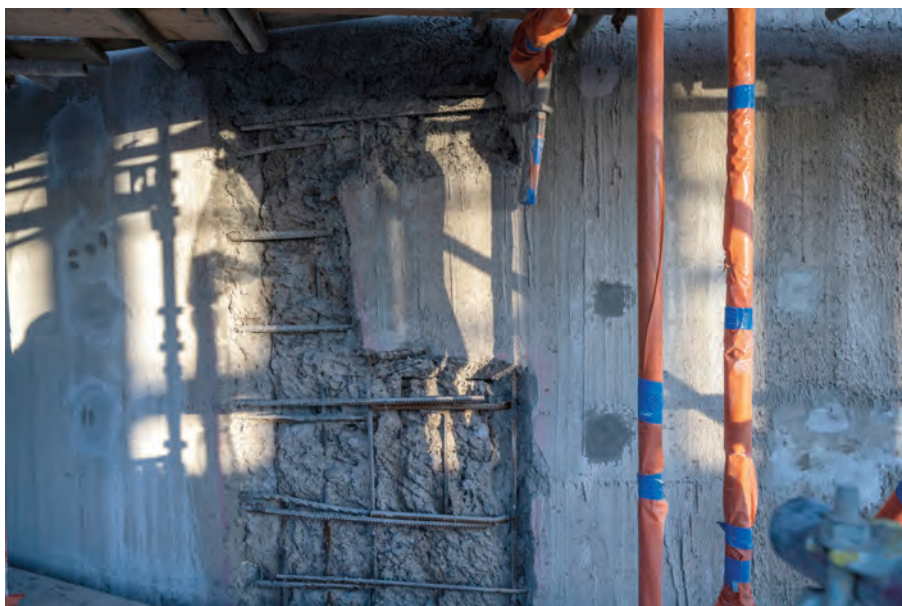
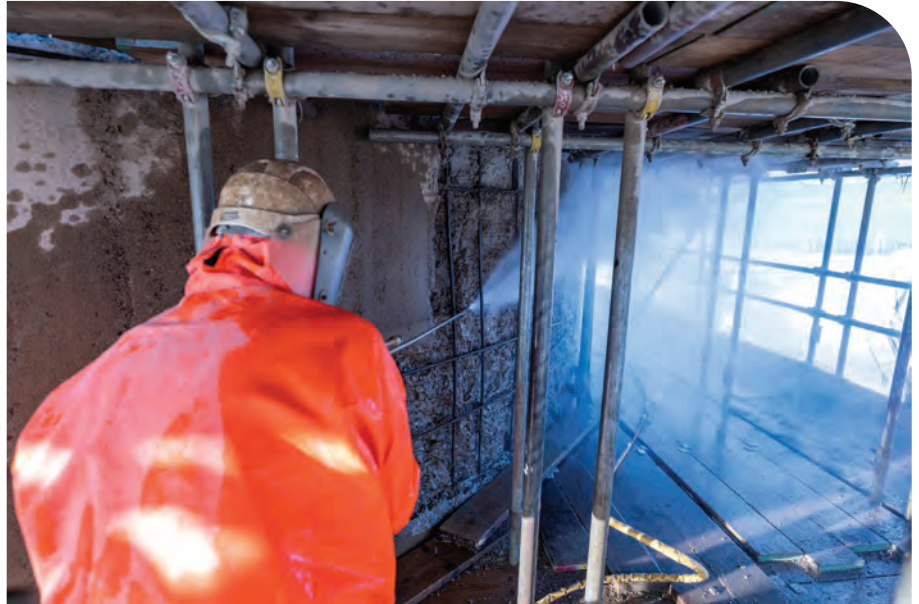
**BELOW LEFT:**  
Figures 5 and 6 – typical areas  
requiring repair.

**RIGHT:**  
Figure 7 – hydro-demolition  
to get behind the reinforcing  
and prepare the patch for  
reinstatement.

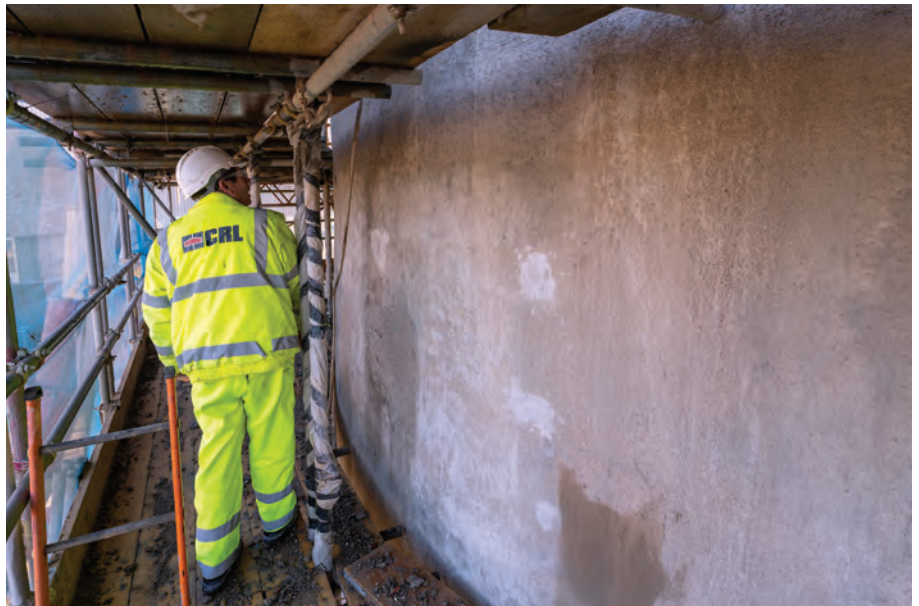
**BELOW RIGHT:**  
Figure 8 – completed repair.

Over 1500 sacrificial anodes were then fixed into the broken-out areas to slow down the corrosion of the reinforcement and prolong its life, thus enhancing the service life of the structure. The concrete repair mortar was then applied using a mixture of hand-applied, and dry-spray techniques. Hand repairs were carried out using Fosroc HBS high-strength, high-build, R4 concrete repair mortar, with the sprayed repairs carried out using Fosroc DS dry-spray repair mortar. The whole structure was then thoroughly cleaned to remove all surface contaminants prior to two layers of a Hydron anti-carbonation coating being applied to help protect the reinforcement from future corrosion problems.
