# A LITTLE CO-OPERATION AND LATERAL THINKING GO A LONG WAY

Established supply chain partnerships and experienced personnel with specialist product knowledge are pivotal to meeting the challenges presented by marine concrete repair projects, as discussed by **Fosroc's Hazel Lowe** in two recent project case studies.

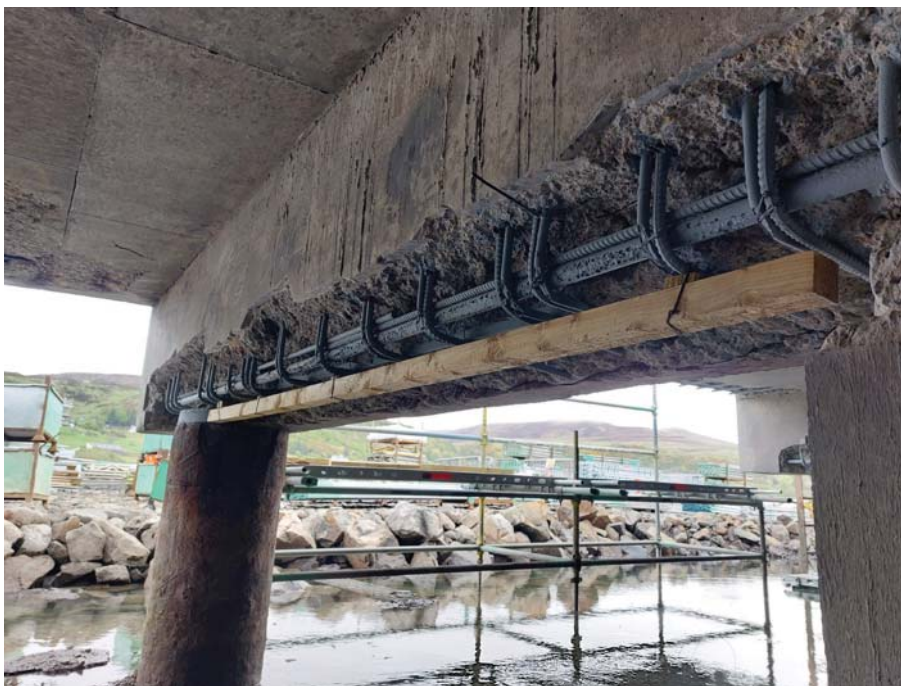
#### BELOW LEFT:

Repairs to the soffits at  
Uig Harbour.

Following the hydro-demolition of the soffit repair, the team were left with repairs up to 170mm deep and 5–6m<sup>2</sup> in some locations. This proved challenging to apply the specified

dry-spray mortar Renderoc DS in a single pass due to the weight of the material in the repair. It was found that the repairs could be applied in two coats, provided the newly hardened material was water-jetted to remove any laitance and loose material before a second layer was applied. In areas at the top of the columns where access for a spray application was impossible, watertight formwork was erected so alkaline micro-concrete Renderoc LA60 could be poured from above. At each stage, the repairs had to be carried out with the tide in mind, as high tide cut off access to the repair areas.

By using hydro-demolition and dry-spray repairs, CRL was able to reinstate up to 5 tonnes of Renderoc DS in a single shift,

between tides. By having the option of using the dry-spray mortar and alkaline micro-concrete together, the obstacle of confinement was overcome, allowing the repair areas to be reinstated. Additional reinforcement was anchored in using a high-performance chemical anchor, ensuring longevity of the solution. During a joint site visit in summer of 2022, RJ McLeod was clearly impressed by the smooth finish achieved and the added value brought by the effective working relationship between Fosroc, CRL and Kestral.
