# CONCRETE

Volume 57, Issue 1 February 2023

Sympathetic repairs to a Grade A listed concrete stand

# NETHERDALE STADIUM, GALASHIELS

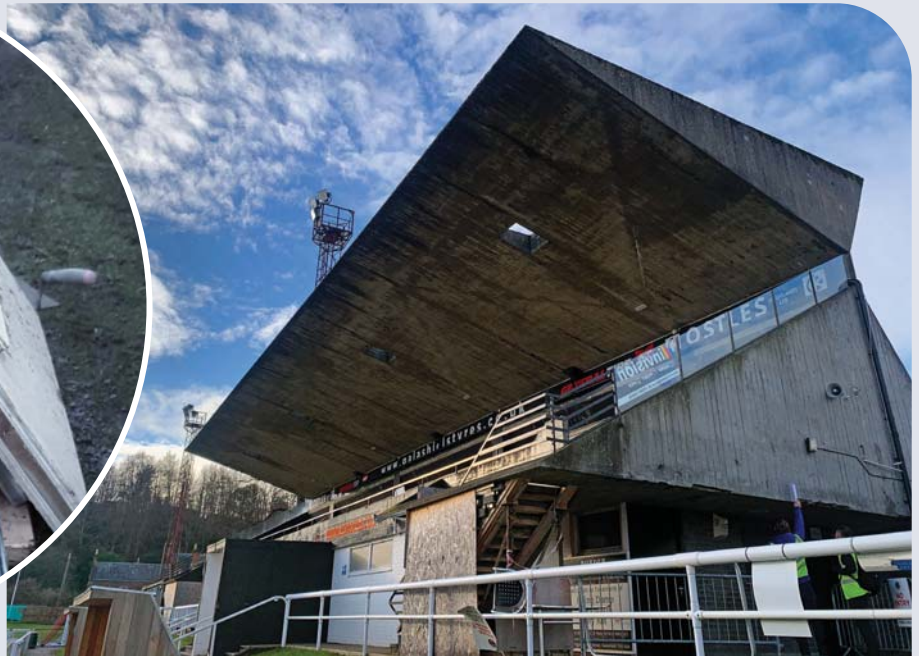
CRL Surveys was commissioned to carry out an in-depth site survey with lab testing of concrete samples. From the results of the survey and tests, it was concluded that the structure was generally in a good condition. However, it was found that the steel reinforcement was positioned too close to the concrete surface and was being affected by moisture, from both the external environment and the high humidity levels within the roof void.

Figure 3 – underside of roof showing patches broken out ready to be repaired (note board-marked finish).

It has to be pointed out that the original construction drawings show that the designed cover for the reinforcement was specified as ½-inch (13mm) to the soffits and 1-inch (25mm) elsewhere, and in the majority of the areas requiring repair, this was found to be the case. Certainly not acceptable by today's standards, but quite common for structures built in the 1960s.

Of the two areas, those within the roof void, where the visual impact of the repair would be minimal, were the easiest to deal with, allowing straightforward concrete repair methods and materials to be used on the underside of the roof. However, the external elevations required a repair strategy that

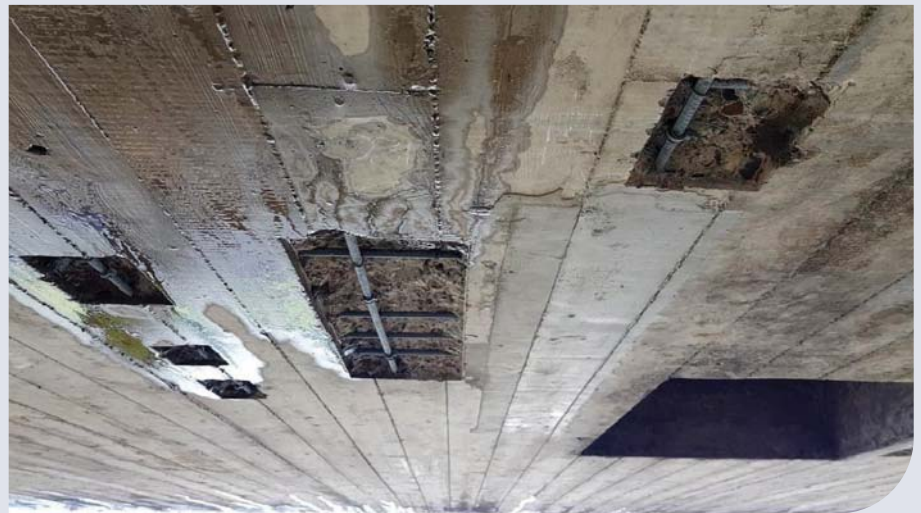
Figure 4 – mock repair used during trials to determine final methodology.

Figure 4 shows a 'mock' repair used during the trials of placing the concrete into the formwork to judge the success of the mix flowing

around the reinforcement and the compaction against the silicone lining. The vertical section on the left is trialling a 'letterbox' system and on the right filling an inclined section through drill holes in the back of the formwork.

It was therefore decided to take silicone casts of the existing surfaces and produce a silicone lining that could be applied to a plywood backing. During the trials, various methods of filling the formwork/ placing the repair material were tested using different mixes and methods to secure the falsework lining in place.

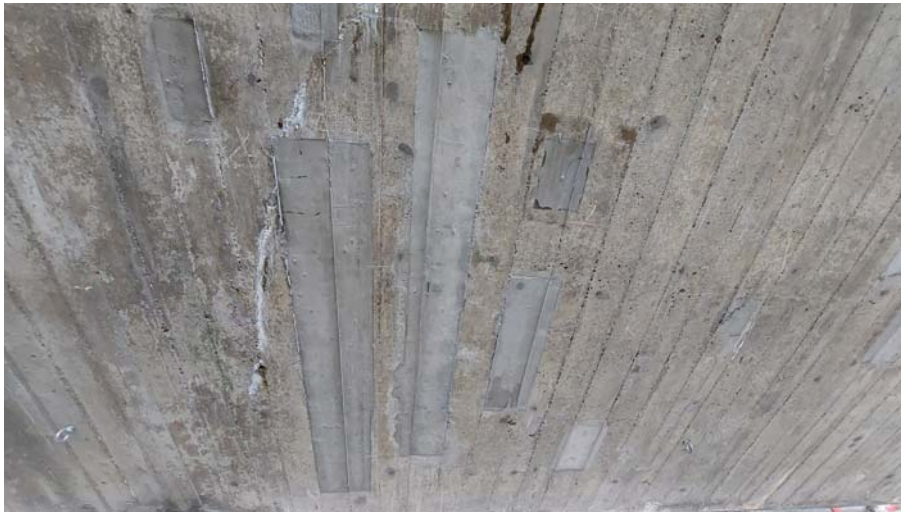
In Figure 5 (page 24), we can see the formwork in place on the underside of the roof; the light-blue material sandwiched between the plywood and concrete is the silicone lining and the blue nibs between the ply are incorporated within the lining to allow grout seepage into them to replicate the original board seepage joints. Figure 6 shows a good example of the falsework used. This system was based on the Unistrut system of components, which is a lightweight system easily adapted to suit the size of repair and for single or multiple repairs.

**LEFT:**  
Figure 5 – trial repairs carried out to the underside of the roof.

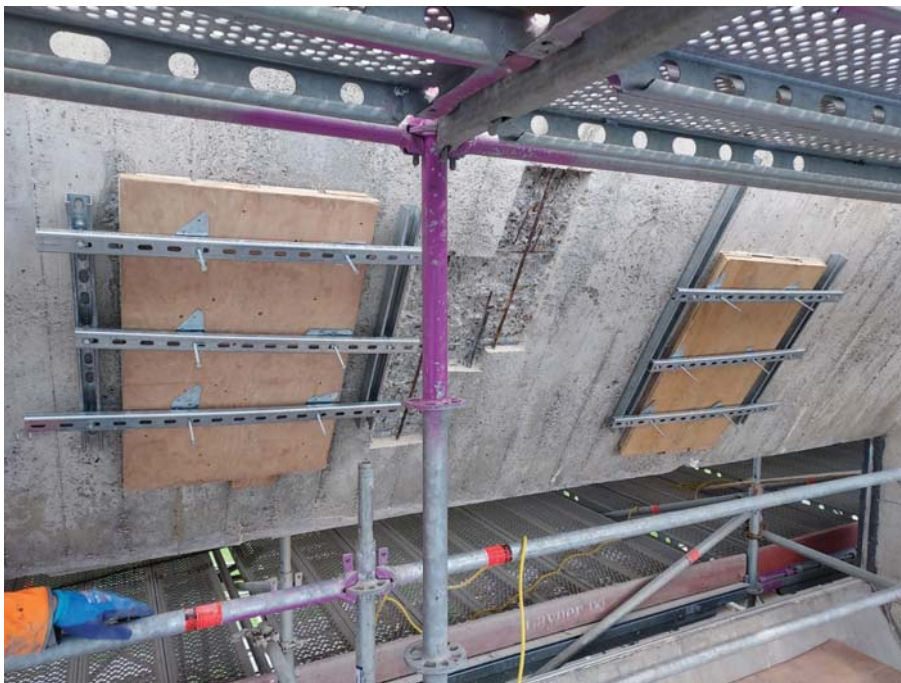
**MIDDLE:**  
Figure 6 – formwork showing the use of the Unistrut system for bracing.

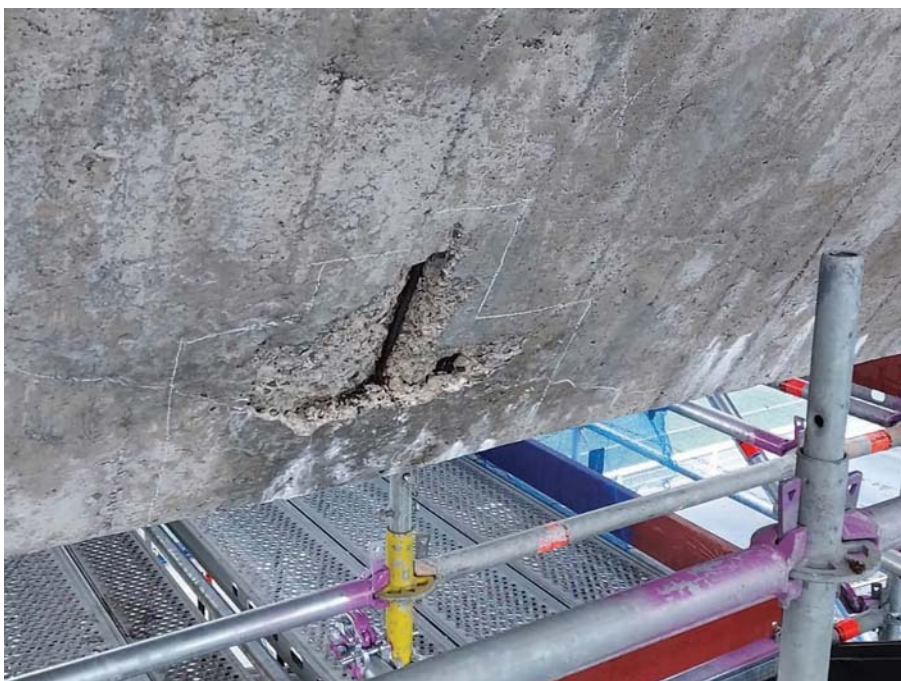
**BOTTOM:**  
Figure 7 – spalled concrete prior to repairs being carried out.

Extensive repairs were also required to the terracing of the stand. This was originally constructed using precast concrete planks acting as permanent formwork, with concrete then poured to form the steps. Sacrificial forms of 200mm-diameter cardboard tubing were used as part of the original construction to minimise the weight of concrete forming the steps. Unfortunately, the cardboard tubing forms an excellent route for any water entering the structure, causing expansive corrosion to the reinforcement situated in the ribs on the bottom of the precast planks and resulting in spalling of the concrete.

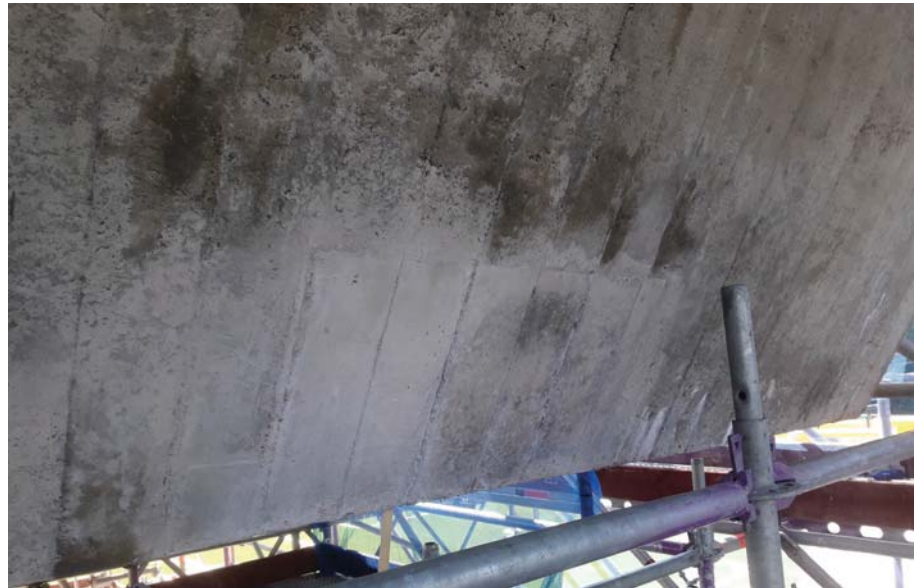
Figure 8 – completed repair using the 'bespoke' concrete.

The preferred material for the repairs, from an aesthetic point of view, was the 'bespoke' concrete, especially in prominent visual locations. To enable this 'bespoke' mix to be used for repair of a greater number of patches, a 10mm aggregate was used, as opposed to the 20mm aggregate in the original concrete. Where it was not possible to use the bespoke concrete, Fosroc Conbextra (a proprietary blended mix of Portland cement, graded fillers and various additives) was used. The Conbextra provided a good colour match, but the repair presented a block of consistent colour, whereas the bespoke concrete provided a desirable variation in colour shades within the repair.

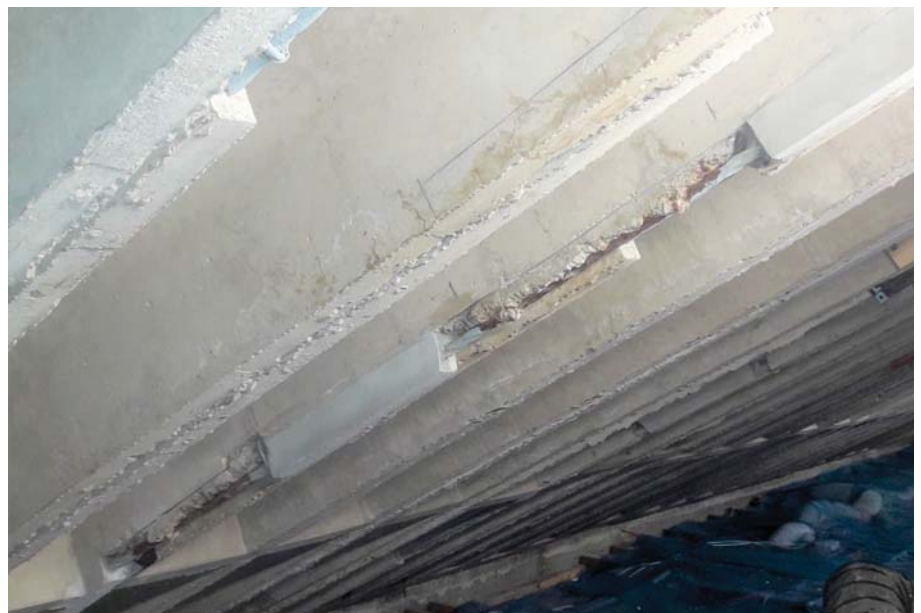
Remedial works to the ribs were carried out by hand application of Fosroc HB45. Due to the length of the spalled concrete areas to the ribs, for structural reasons the trimming up of the spalled area and subsequent repair could only be carried out in a 'hit and miss' sequence of 500mm. Figure 9 illustrates the sequencing with repairs at various stages. In total, 277 repairs were carried out within the void, with a total length approaching 165m.

Figure 9 – repairs to the ribs showing the 'hit and miss' sequence.

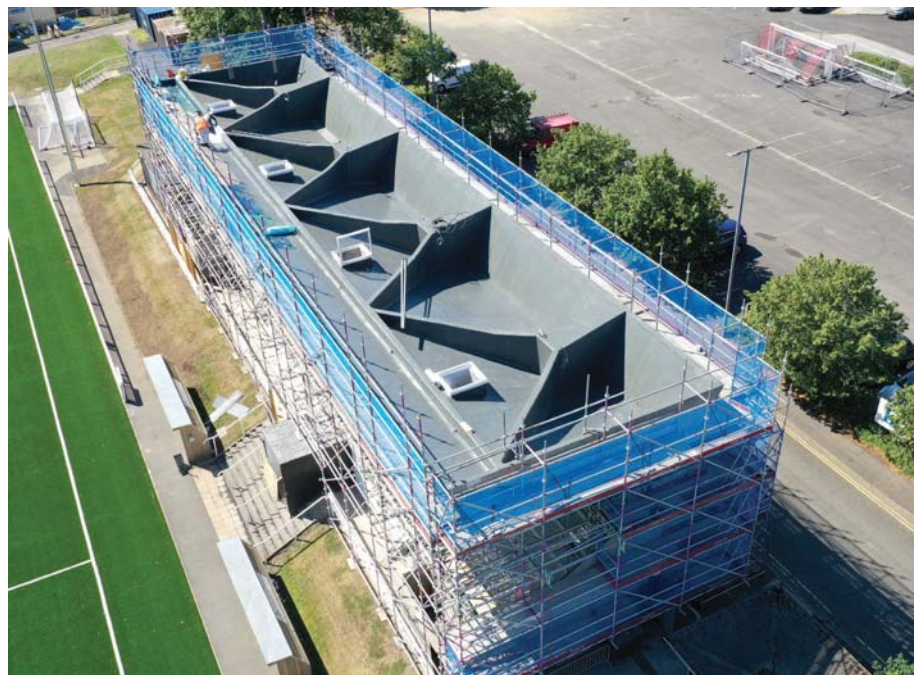
Figure 10 – the completed waterproofing membrane to the roof.

The drainage channel to the rear of the roof was reformed to provide falls to the two outlets on the roof. Drainage holes were enlarged and additional holes cored through the beams to allow rainwater to flow to the channel. Finally, a waterproof membrane system was applied to the main roof and to both turnstile roofs.
