# Giving Guildford's gateway a makeover

The distinctive Farnham Road car park in Guildford has been given a thorough overhaul by Concrete Repairs using Sika systems

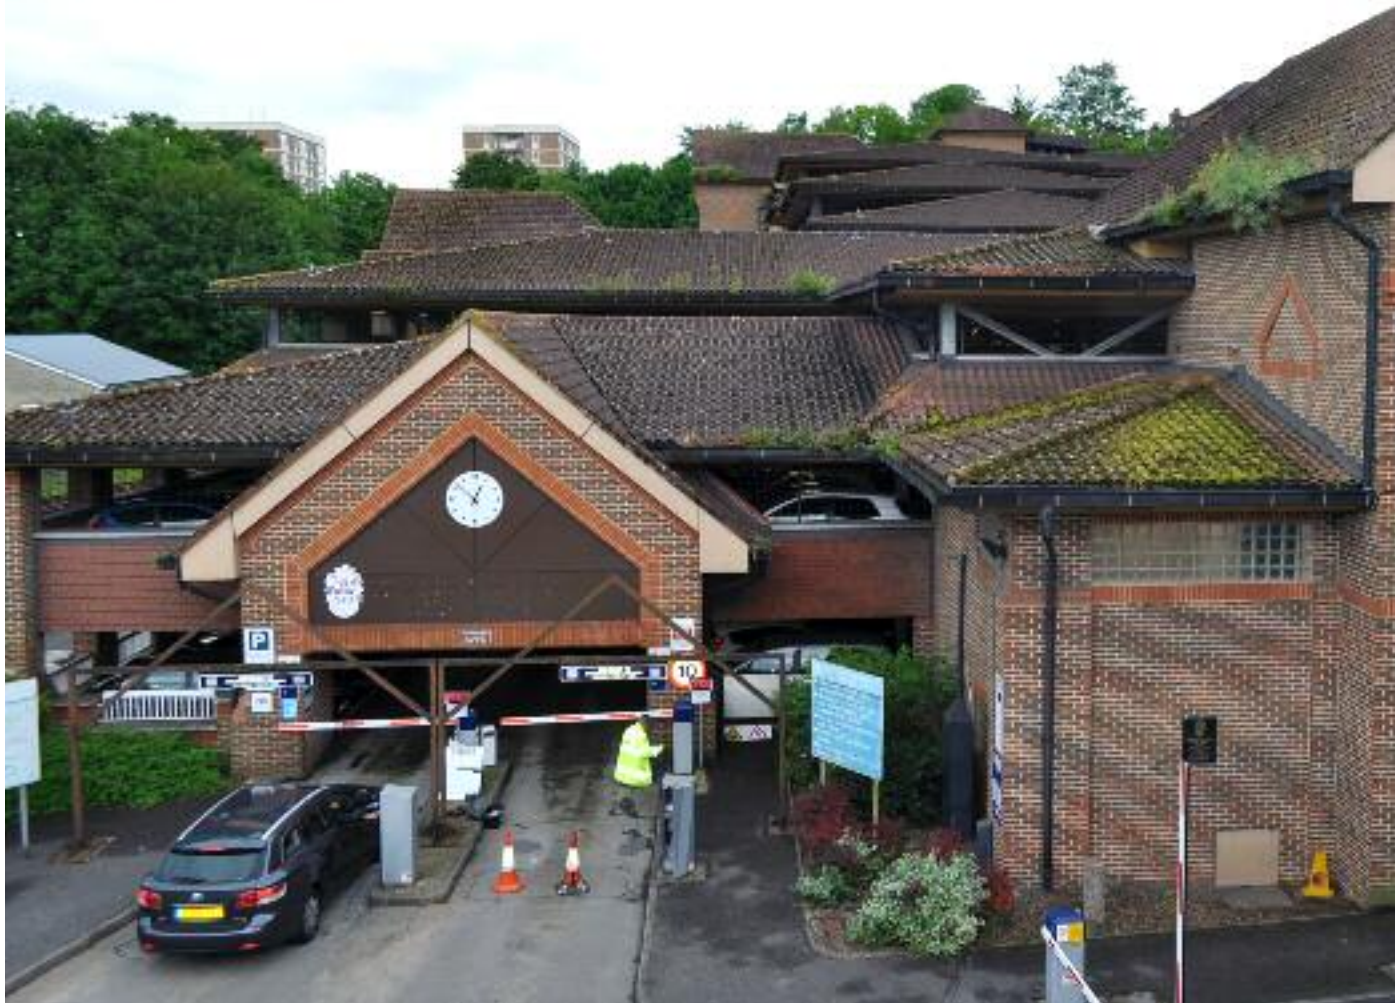
Farnham Road before the refit, complete with blocked gutters
